Monitoring Streambanks and Riparian Vegetation

Multiple Indicator Monitoring

Ervin Cowley and Tim Burton

June 2004

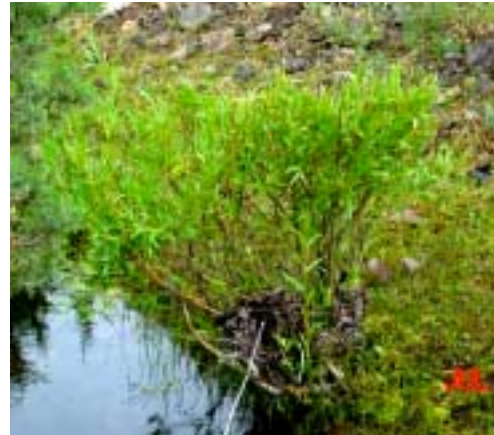
Figure 3—Little or no hedging – Two-year-old wood is relatively long and only slightly unaltered. Most riparian species grow with a strong central stem with annual growth from a terminal bud. The central stem is relatively unaltered.

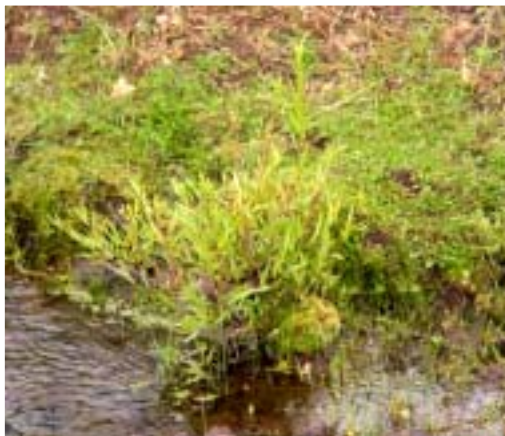
Figure 4—Moderately Hedged- Two-year-old wood is fairly long but most of it has been altered from the normal growth form. The central stem has multiple branching from the one point.

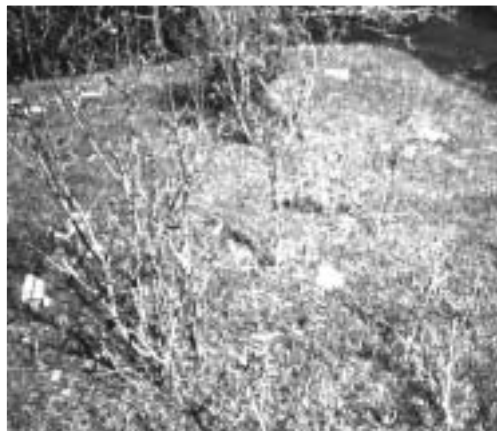
Figure 5—Severely hedged – Two-year-old wood is relatively short and/or strongly altered. Strong branching from a single point on the central stem is evident.
